**EMERGENCY INSPECTION REPORT
KUAMO'O HIGHWAY ROCK SCALING
LIHUE, KAUAI, HAWAII**

Dates of Inspection: *March 31, 2014 and April 15, 2014*

Subject: *Concerns regarding unstable geologic features*

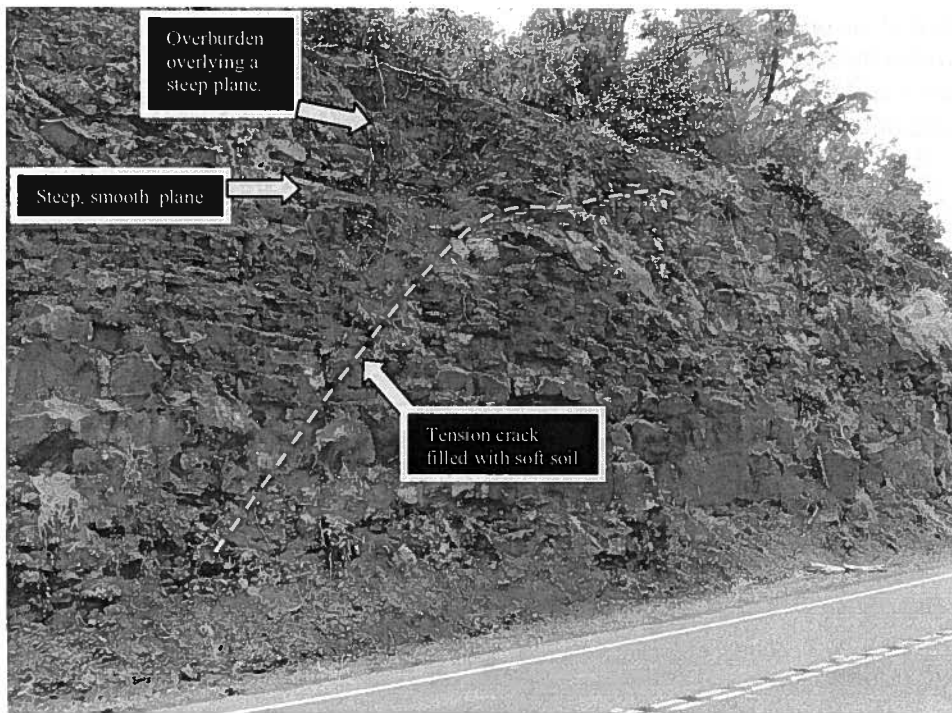
1. Near currently marked station 00+300 and about three quarter of the way up along the mauka direction, rock scaling has exposed a relatively steep and solid plane (see Photo 1 through Photo 3). Above the steep plane, the overburden is composed of crumbling rocks and soil which appears to be typical of this cliff formation and the result of exposure to the natural elements and continual weathering. A tension crack has already opened up at the very top of the cliff (above and along the back side of the overburden) near the tree line. The concern is with heavy rain and a frequently occurring vibration generated by the vehicles traveling on the highway below that could potentially release the top overburden down onto the highway. There is also a second major feature in this area, another tension crack which has opened up wide, but is currently filled with soft soil and other debris. The concern here is again penetration of rain water through the debris into the space within the crack creating large hydrostatic forces which could potentially cause a massive rock slide.

Photo 1. Note presence of a relatively steep plane and the overlying overburden.

Considering the construction costs, ease of implementation, and a shorter installation time to address this urgent safety condition, we would like to recommend installation of a heavy duty double drapery system along the entire length of the above mentioned segment (600 linear feet) for an estimated construction cost of about \$1,755,000 and a construction time of 4 months.

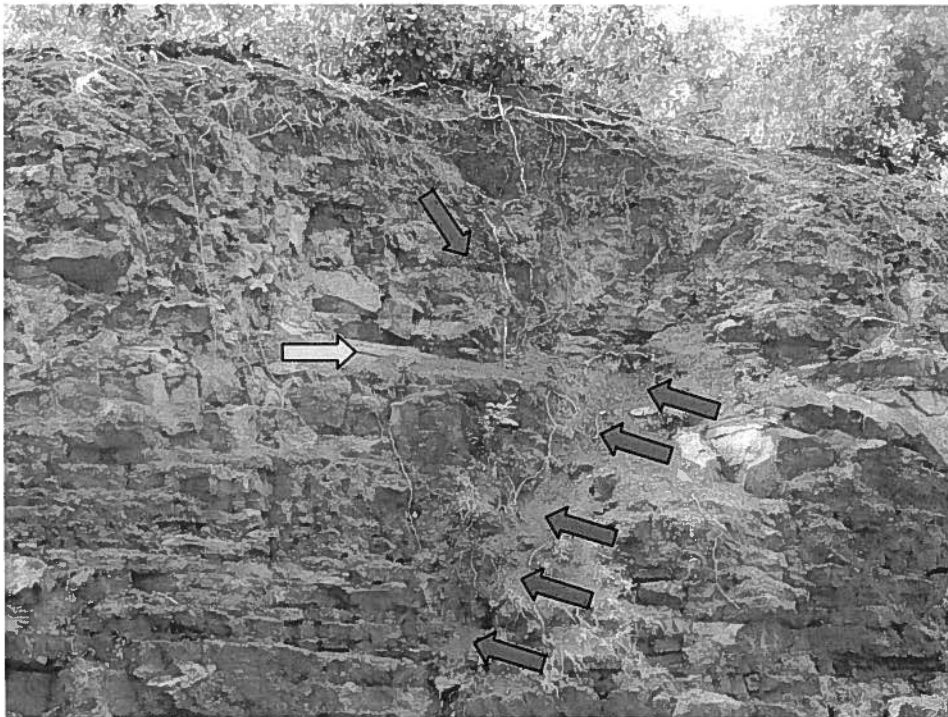
Photo 2. Close up view of steep and smooth plane (yellow arrow), softer overburden above (blue arrow), and a soil filled tension crack (red arrows).

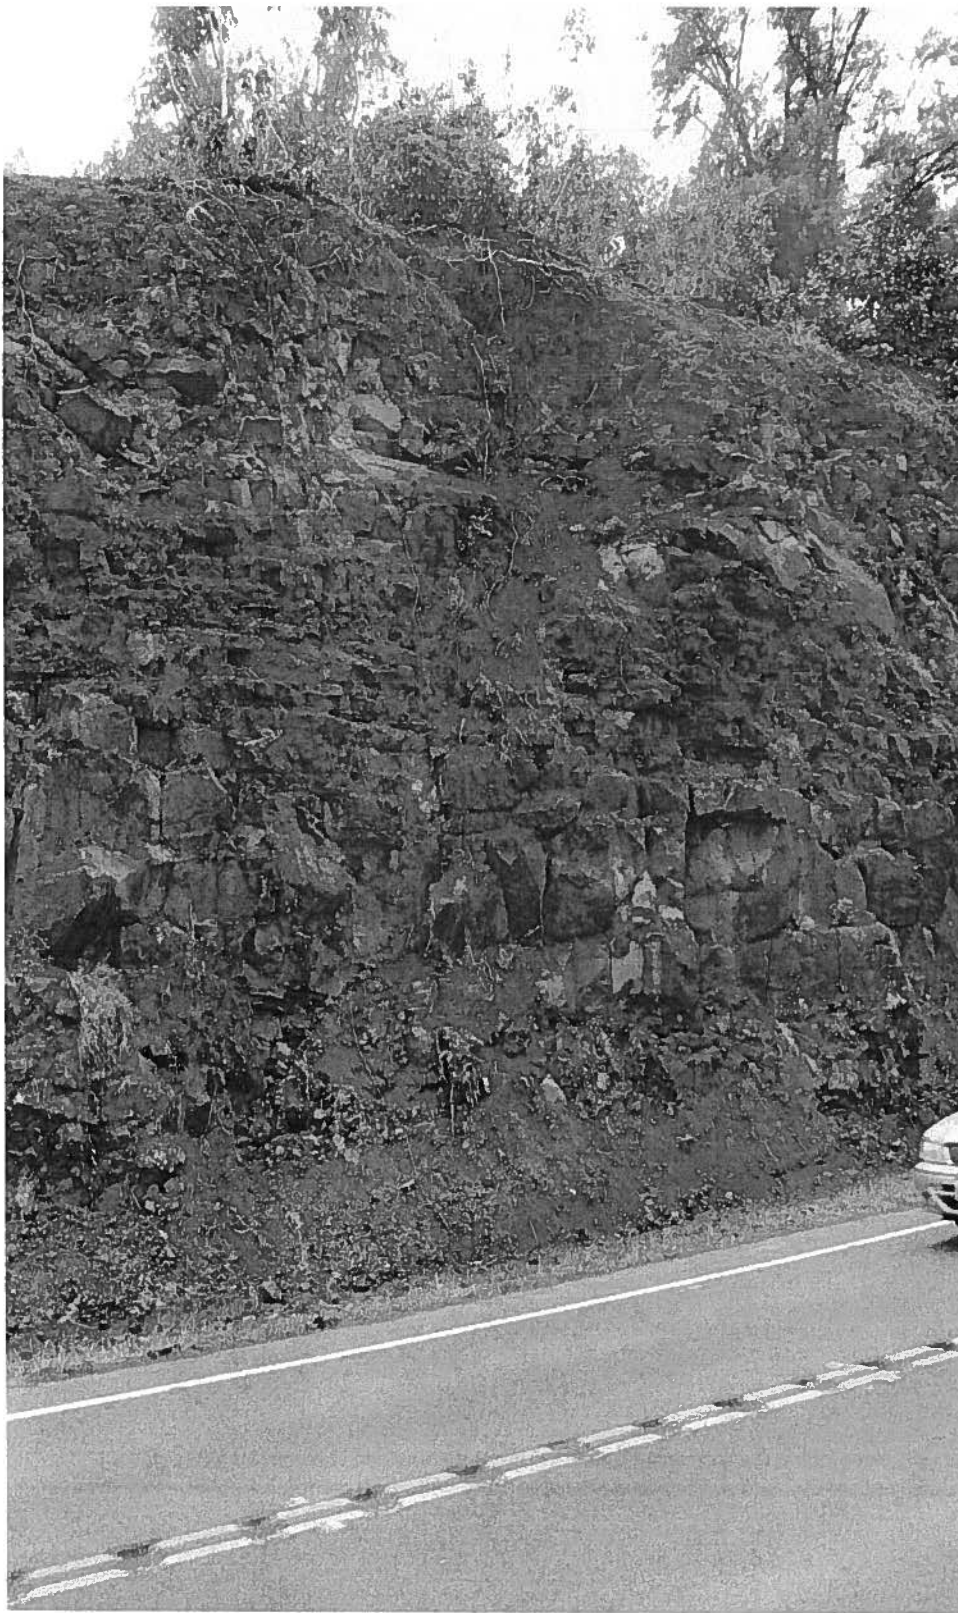
Photo 3. Another view of unstable features of the cliff and its proximity to the traffic.

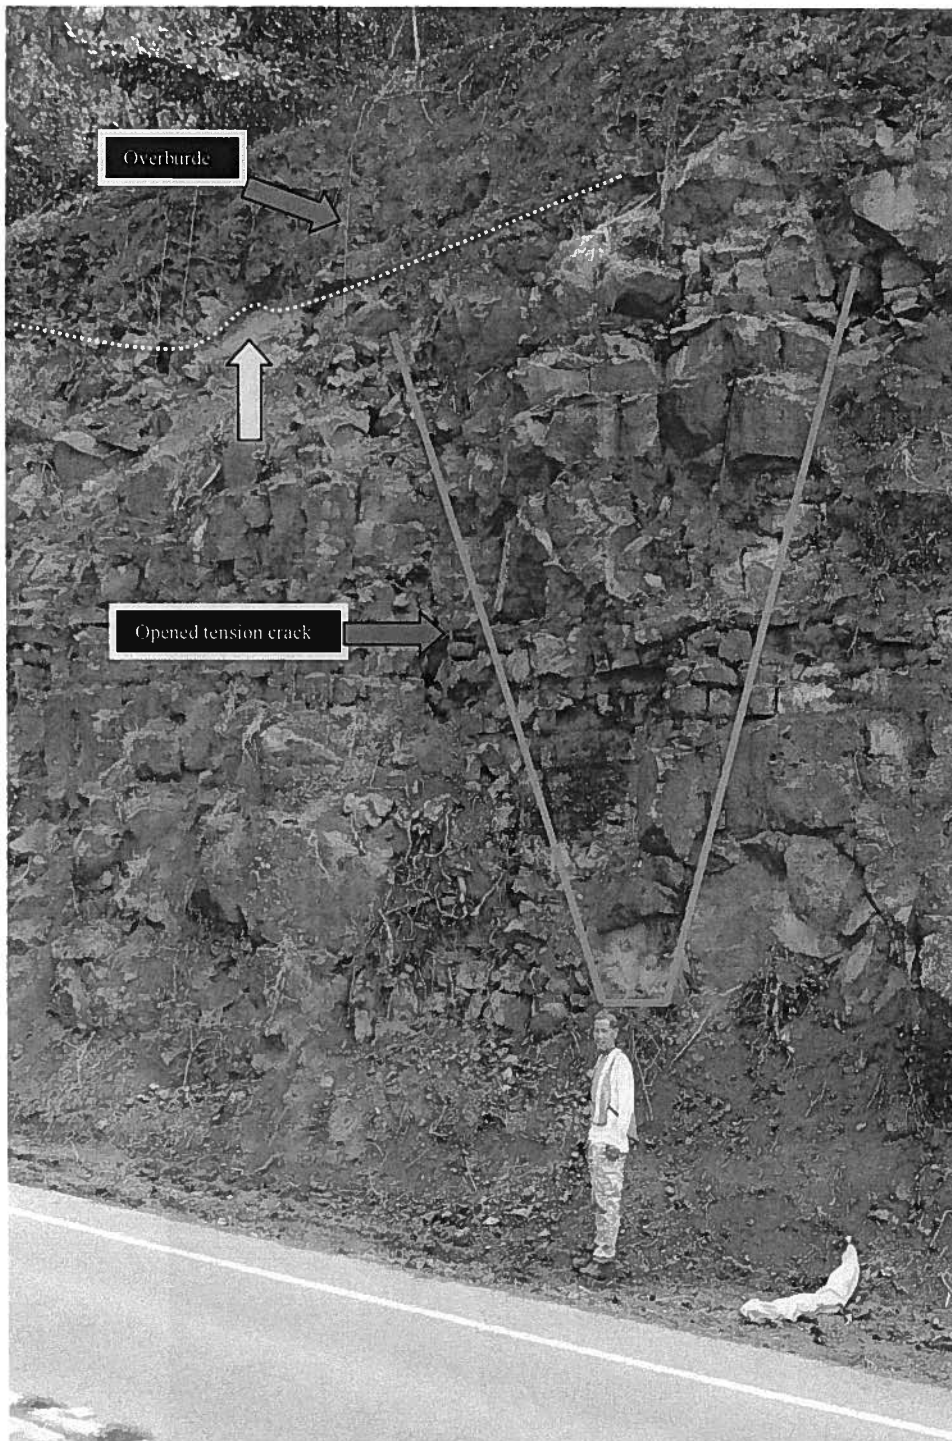
2. Near the current station marked 00+550, we noted a similar condition as Item 1 above, but in a more severe state. See Photo 4 below. Again, we noted a very steep plane made up of a relatively smooth and hard rock outcrop supporting an overburden of soils and rocks with a tension crack opened up near the tree line. During rock scaling work at night, rock scalers reported feeling vibrations every time someone farther away tried to release surface rocks with a crowbar. In addition, a tension crack along the side of the cliff has opened up several inches, and a massive wedge shaped feature with little support along the bottom of the wedge composed of highly fractured and flaky rock features is clearly exposed to view. This geologic wedge shape element has a somewhat heavy upper part making it prone to overtopping. Also see Photo 5 below.

Photo 4. Note the very steep plane (yellow arrow), the overlying overburden (blue arrow), opened tension crack (red arrow), and a massive wedge with little bottom support (solid blue lines).

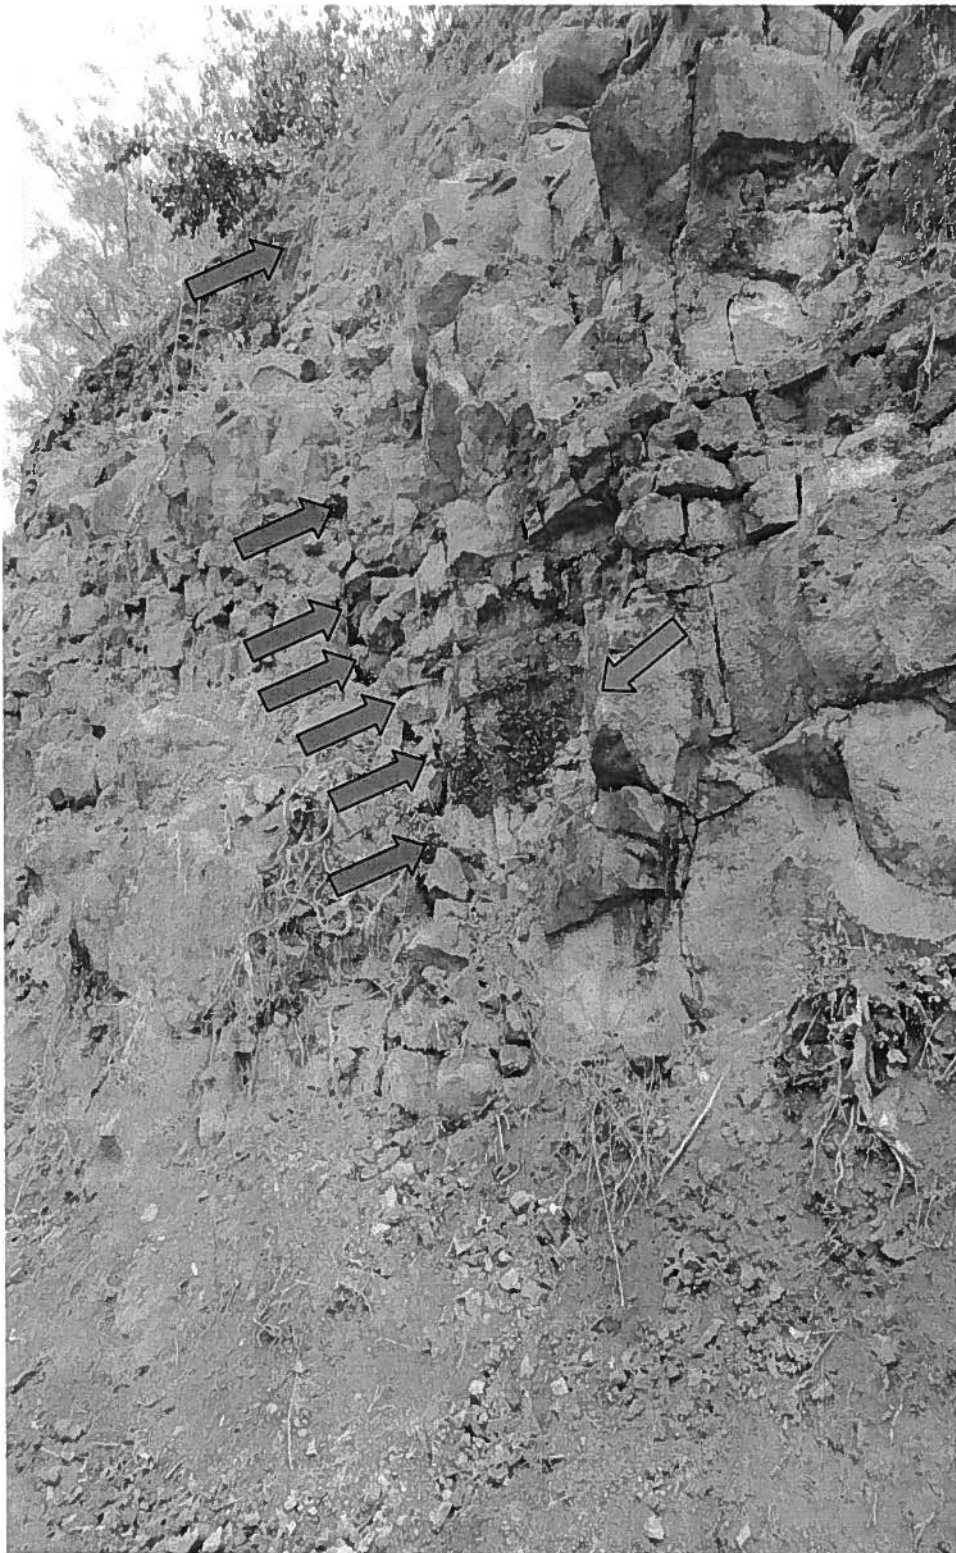
Photo 5. Another view of the cliff face at station 00+550. Note the overburden material (blue arrow); the steep plane not in view), tension crack (red arrows), and the massive wedge feature with little bottom support (green arrow).
